Report No. FHWA RD 74 19

HYDRAULIC CHARACTERISTICS OF TWO BICYCLE SAFE GRATE INLET DESIGNS

November 1974
Final Report

FEDERAL HIGHWAY ADMINISTRATION
Office of Research & Development
Washington, D.C. 20590

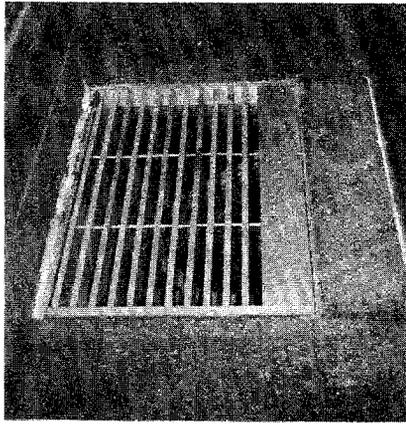
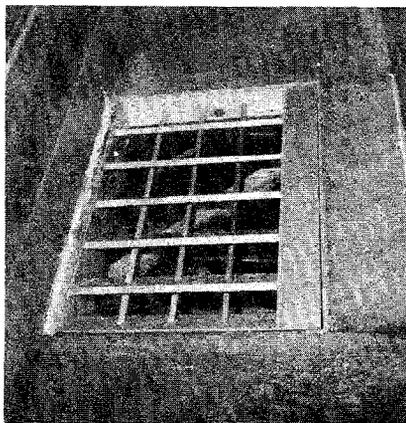
PHOTO 2. GRATE MODELS

ORE-L GRATE

TB45-3 GRATE

ORE-T GRATE

TBV-3 GRATE

TB45-1 GRATE

MASSACHUSETTS CASCADE GRATE

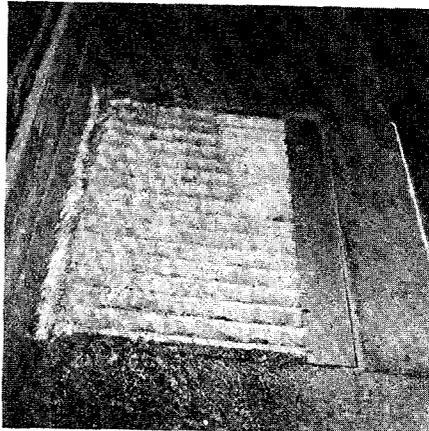
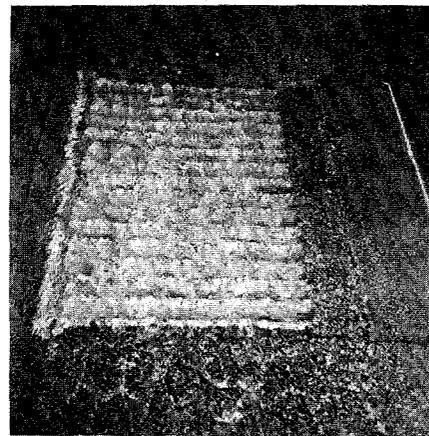
PHOTO 4. GRATE ORE-T

Low Flow, Slope 0.005

High Flow, Slope 0.005

Low Flow, Slope 0.075

High Flow, Slope 0.075

Photos 3 through 9 show the grates under test conditions on slopes of 0.005 and 0.075 and under low and high gutter flow conditions. Photo 6 shows the TB45-3 grate also being tested on a slope of 0.028. Photos 8 and 9 show the Massachusetts grate also being tested on slopes of 0.028 and 0.013, respectively.

Water skipping and splashing were virtually nil for the very flat slopes, especially the .005 slope, and were noticeable at all only for the two transverse bar grates, ORE-T and TBV-3. For steep slopes, splashing was noticeable for all grates but was worst for TBV-3, and skipping or skimming was especially prominent for the grates with transverse bars (ORE-T, TBV-3, and MASS). At the .075 slope and at the flow of 3.2 cfs ($0.0906 \text{ m}^3/\text{sec}$) water skipped over the bars of the ORE-T grate so completely that hardly any splashing was observed.

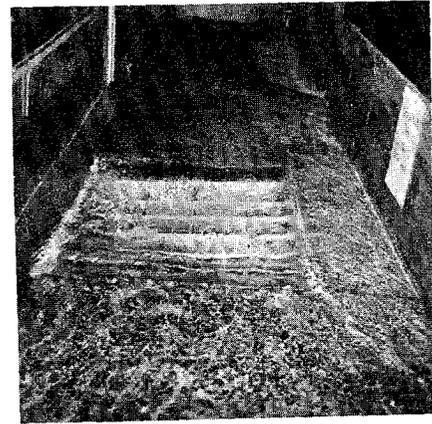
PHOTO 6. GRATE TB45-3

Low Flow, Slope 0.005

High Flow, Slope 0.005

Low Flow, Slope 0.028

High Flow, Slope 0.028

Low Flow, Slope 0.075

High Flow, Slope 0.075

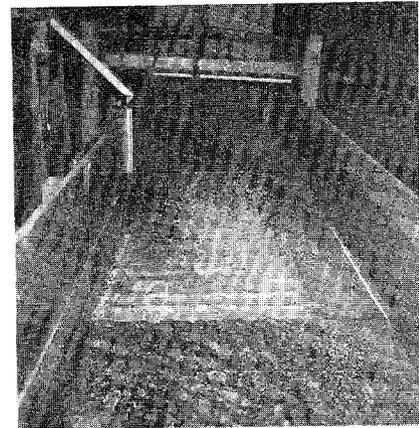
PHOTO 7. GRATE TBV-3

Low Flow, Slope 0.005

High Flow, Slope 0.005

Low Flow, Slope 0.075

High Flow, Slope 0.075

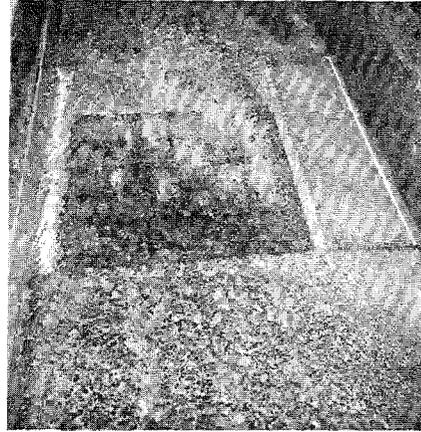
PHOTO 9. MASSACHUSETTS CASCADE GRATE (Continued)

Low Flow, Slope 0.13

High Flow, Slope 0.13
